THE PARKFIELD, CALIFORNIA, EARTHQUAKE
OF
JUNE 27, 1966

PRELIMINARY SEISMOLOGICAL REPORT

PRELIMINARY ENGINEERING SEISMOLOGICAL REPORT

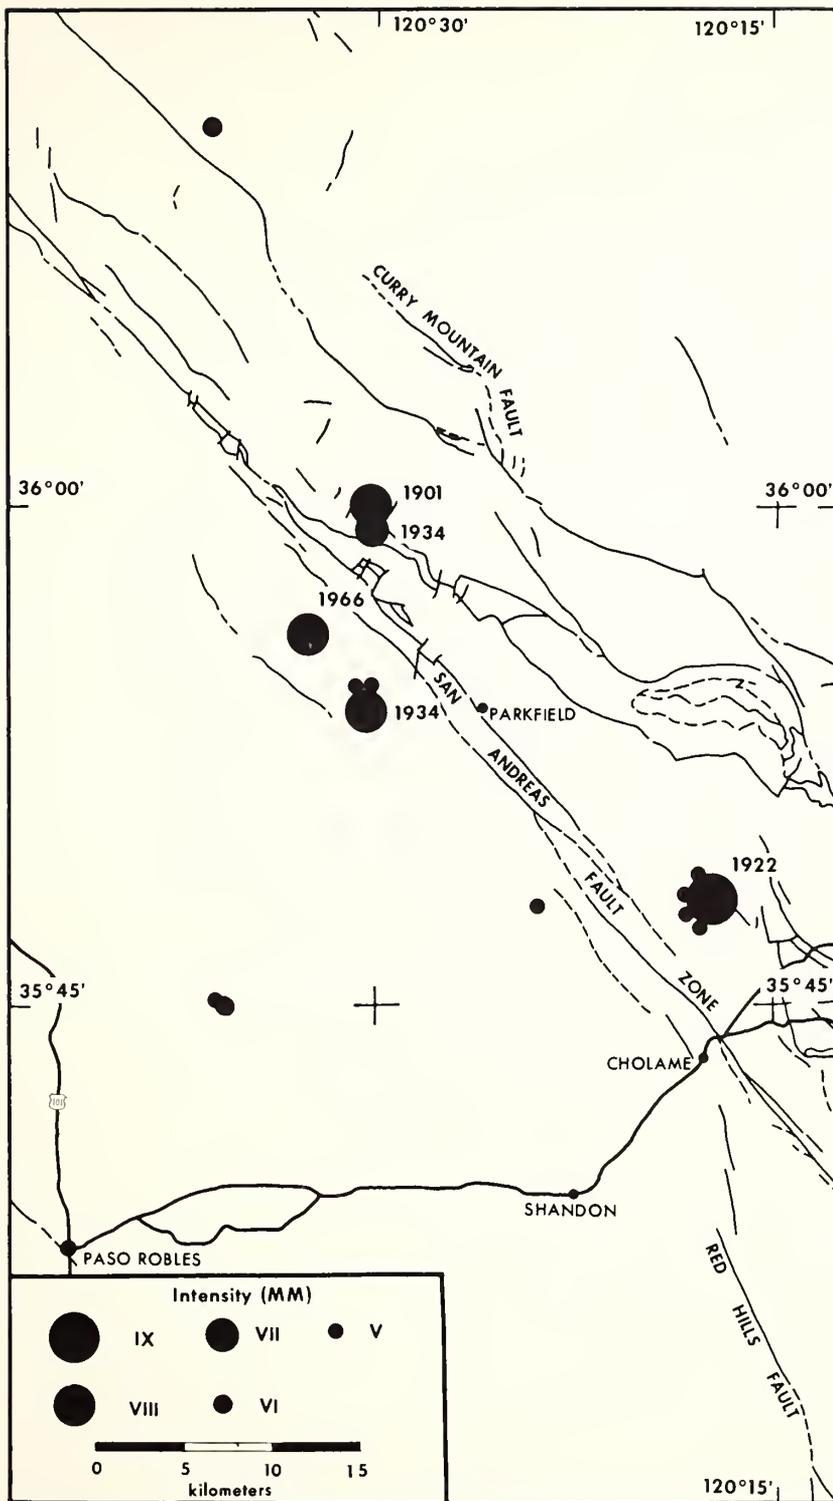
FIGURE 1.—Earthquakes (intensity V or greater) in the Cholame-Parkfield, California area.

Historically, the Parkfield-Cholame area has been subjected to frequent earthquakes of moderate intensity. Table 1 lists the earthquakes with Modified Mercalli intensity of V or greater since 1769. Figure 1 shows the locations, where possible, of the earthquakes listed in table 1. The largest earthquake in this region occurred on March 10, 1922. Its epicenter was located 18 miles southeast of the 1966 earthquake, near the town of Cholame. The Modified Mercalli intensity was IX, according to Eppley (1966), and it was felt over 100,000 square miles. Pipelines crossing the Cholame Valley were ruptured by this shock, and considerable damage was done to existing structures in the Valley.

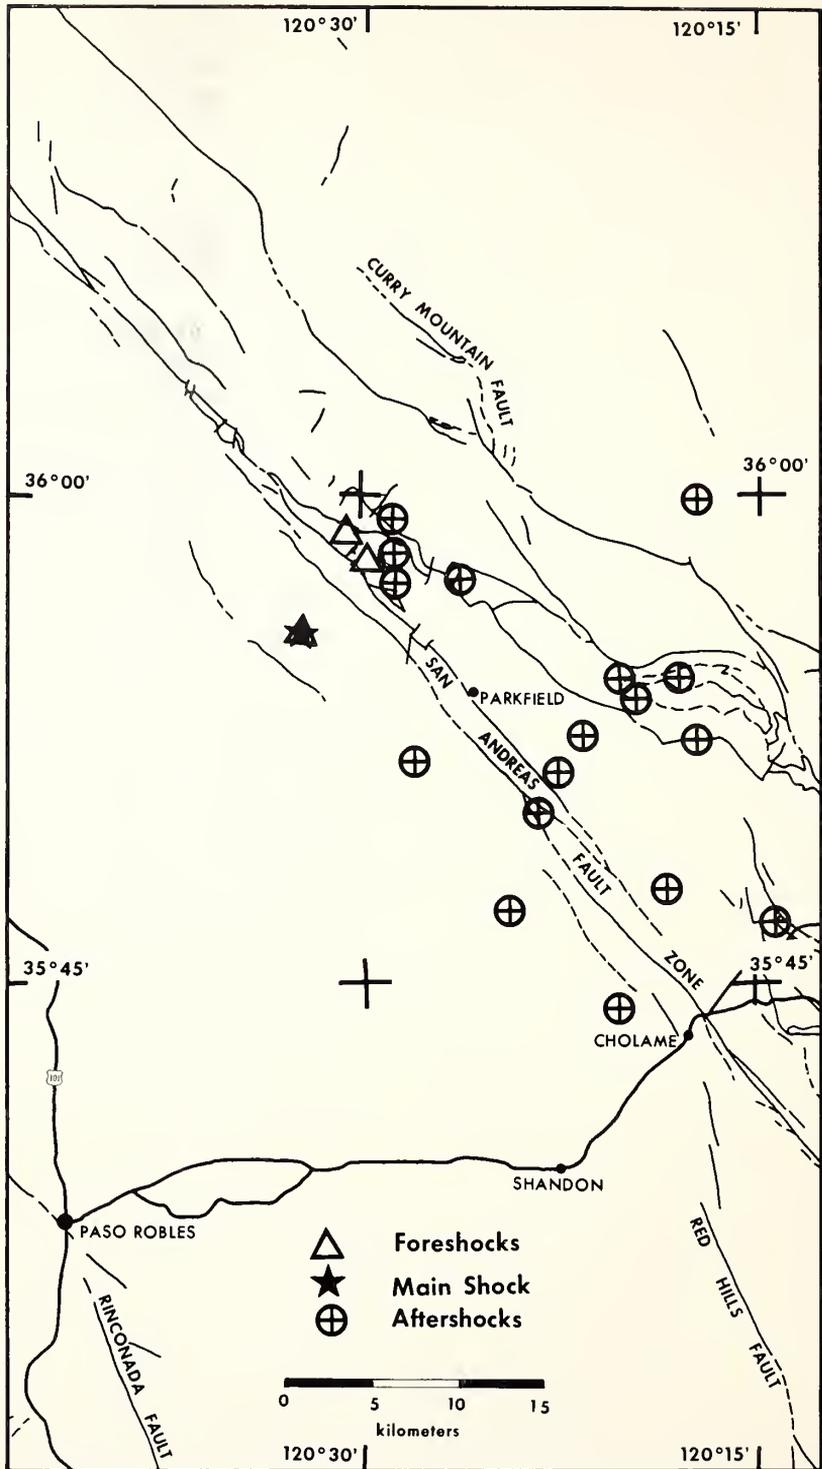
FIGURE 2.—Location of epicenter of June 28, 1966 (G.M.T.) earthquake, foreshocks, and aftershocks.

solution used to determine the epicenter and origin time. Table 2 is a list of these earthquakes, three of which are considered foreshocks, and twenty-two are aftershocks. These earthquakes are plotted in figure 2, with the exceptions of one aftershock on June 28 and three aftershocks on July 2, which fall outside the coordinates of the map.

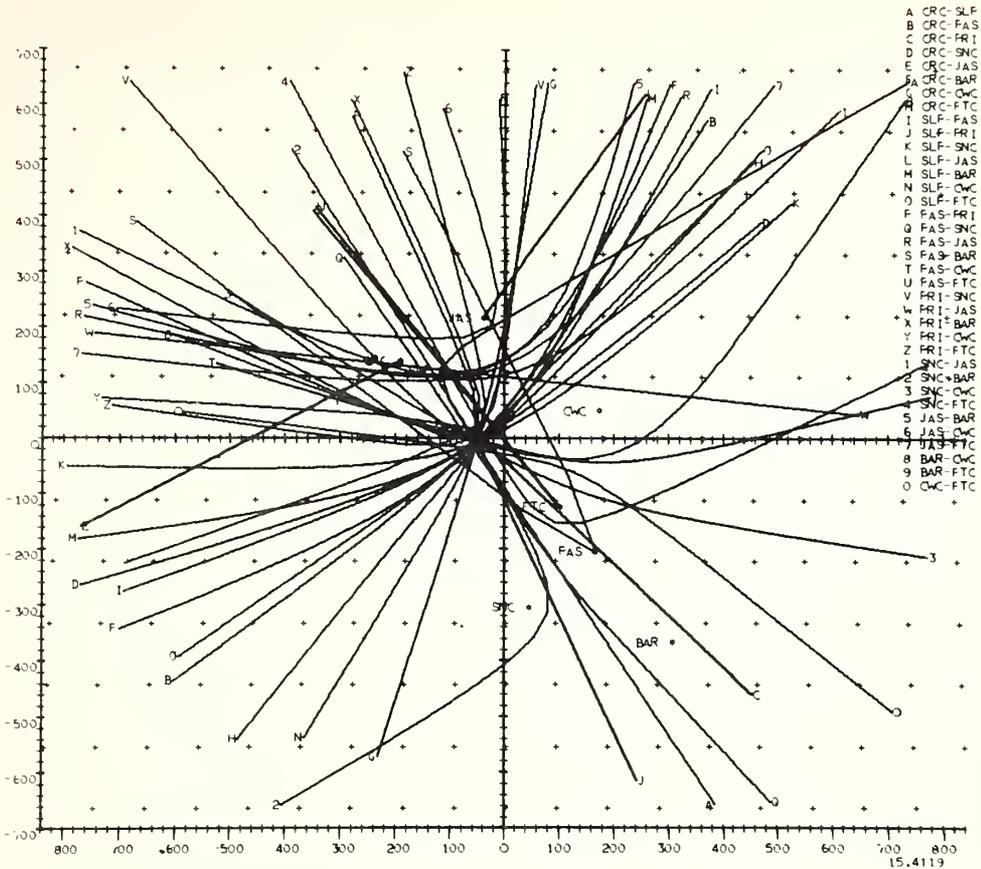
FIGURE 3.—Time difference hyperbola plot of main earthquake occurring at 04:26:14.4 G.M.T., June 28, 1966.

Figures 3 and 4 are time difference hyperbola plots of the arrival times for the first nine-station pairs reporting the main shock and a major aftershock. The origin of the coordinates of the plot is 36° N., 120° W. The scale is in kilometers and the plus signs are the intersections of the geographic meridians and parallels. The plots were made on the cathode ray oscilloscope plotter attached to the IBM 7030 computer during the preliminary data pass. The main event, figure 3, clearly shows intersection of numerous hyperbola at about $x = -40$

and $y = -10$ (approximately 35.9° N., 120.5° W.). It also shows that the arrival time at station JAS (Jamestown) associated with hyperbola E, L, R, W, 1, 5, 6, and 7 does not fit the solution. This station's data were removed from the hypocenter computation during the final data pass. The plot of the June 28 aftershock (04:39:08.9 G.M.T.) shows the intersection of all hyperbola at about $x = -40$, $y = -10$ (approximately 35.9° N., 120.5° W.). There are no apparent errors in the input data. Time difference hyperbola plots were made for each event to assist in the removal of arrival times which were in error and to suggest a first approximation of epicenter location to the least-squares iterative

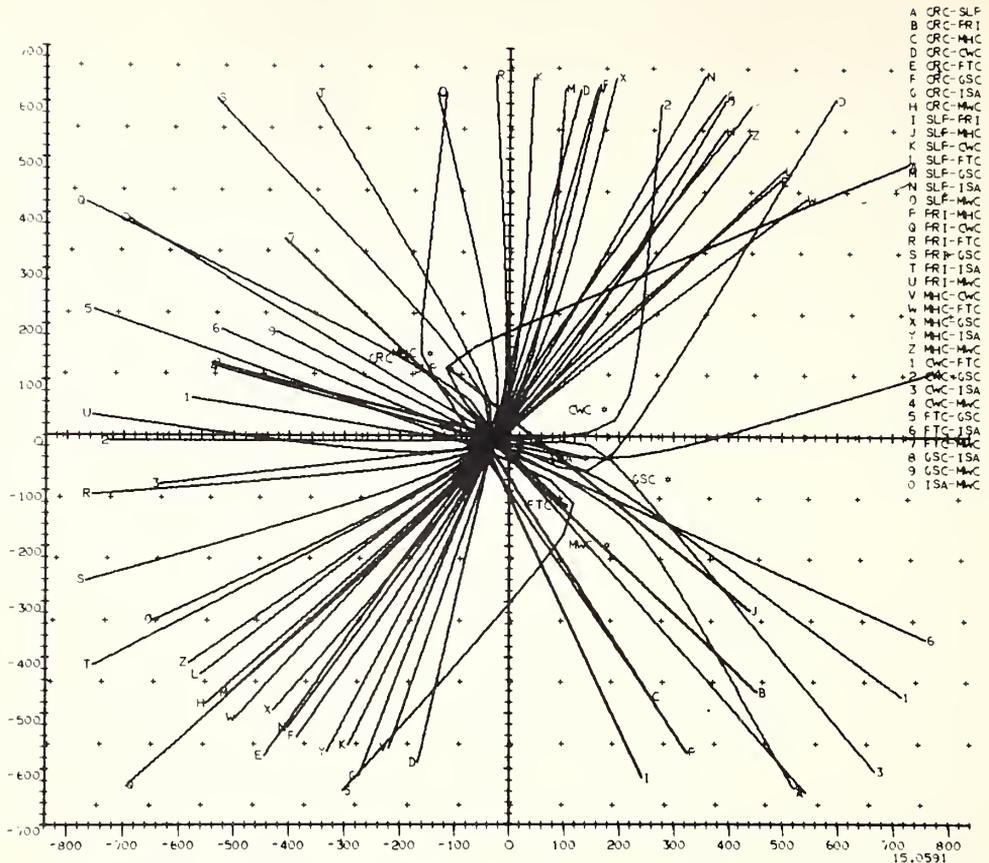
FIGURE 4.—Time difference hyperbola plot of major aftershock occurring at 04:39:08.9 G.M.T., June 28, 1966.

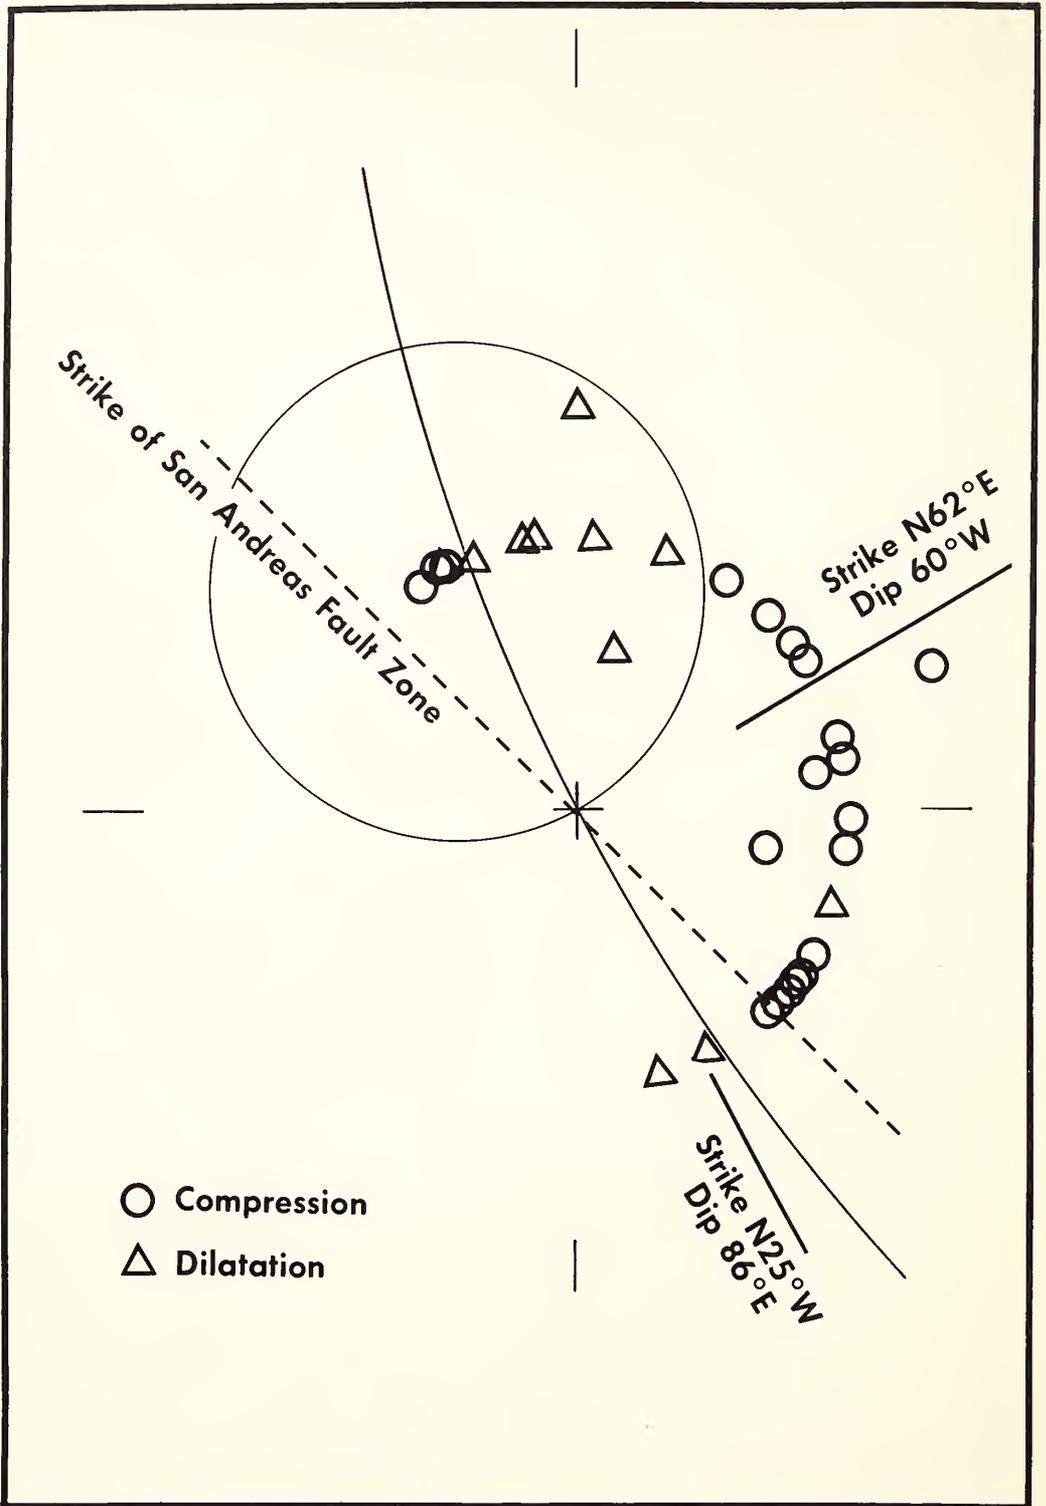
FIGURE 5.—Stereographic projection showing the first motion and direction of nodal planes.

Figure 5 is an extended distance plot in stereographic projection of the direction of first motions of the 38 stations used in the solution. The circles represent the A and B planes found for this earthquake. The smaller circle in figure 5 represents the A plane and the larger circle, the B plane. The A plane has a strike of $N.62^\circ E.$ and dips $60^\circ W.$ The B plane, restrained by the orthogonality criterion, strikes $N.25^\circ W.$ and dips $86^\circ E.$ The strike of the San Andreas fault in this region is $N.44^\circ W.$ The B plane is oriented $N.25^\circ W.,$ which is 19° east of the strike of the San Andreas fault. This nodal plane indicates right-lateral motion. The A plane is nearly transverse to the regional structure, figure 7. No attempt is made in this discussion to differentiate between the fault plane and the auxiliary plane, since this would imply that the earthquake is classified as a single couple. This cannot be determined by the method used. Work is progressing on an S -wave solution which should enable the authors to better evaluate the nature of the focal mechanism.

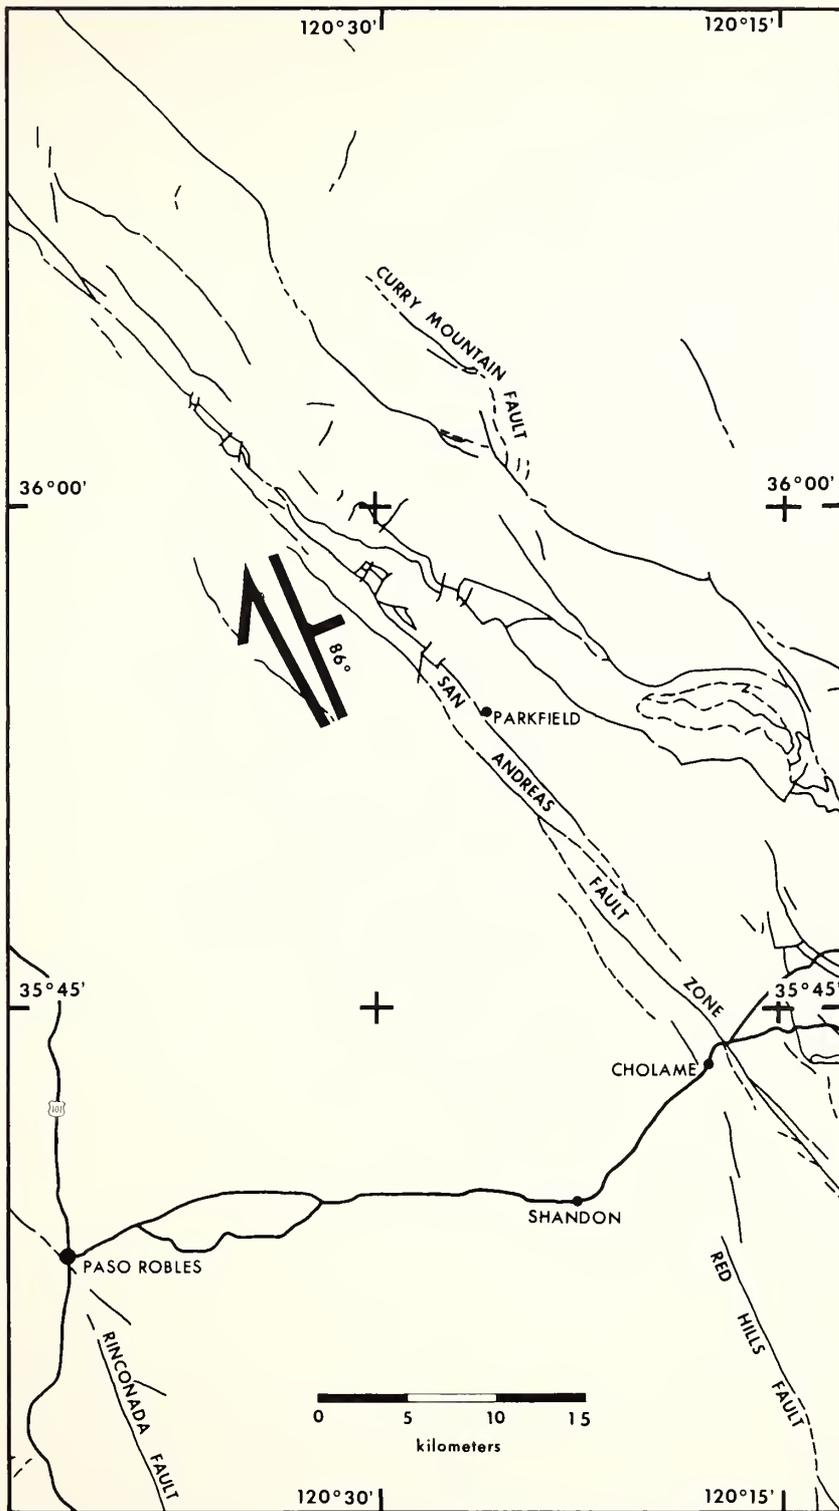
FIGURE 6.—Comparison of nodal plane solutions of June 28, 1966 (G.M.T.) earthquake to regional faulting B plane.

The B nodal plane of the focal mechanism study is oriented 20° east of the strike of the San Andreas fault.

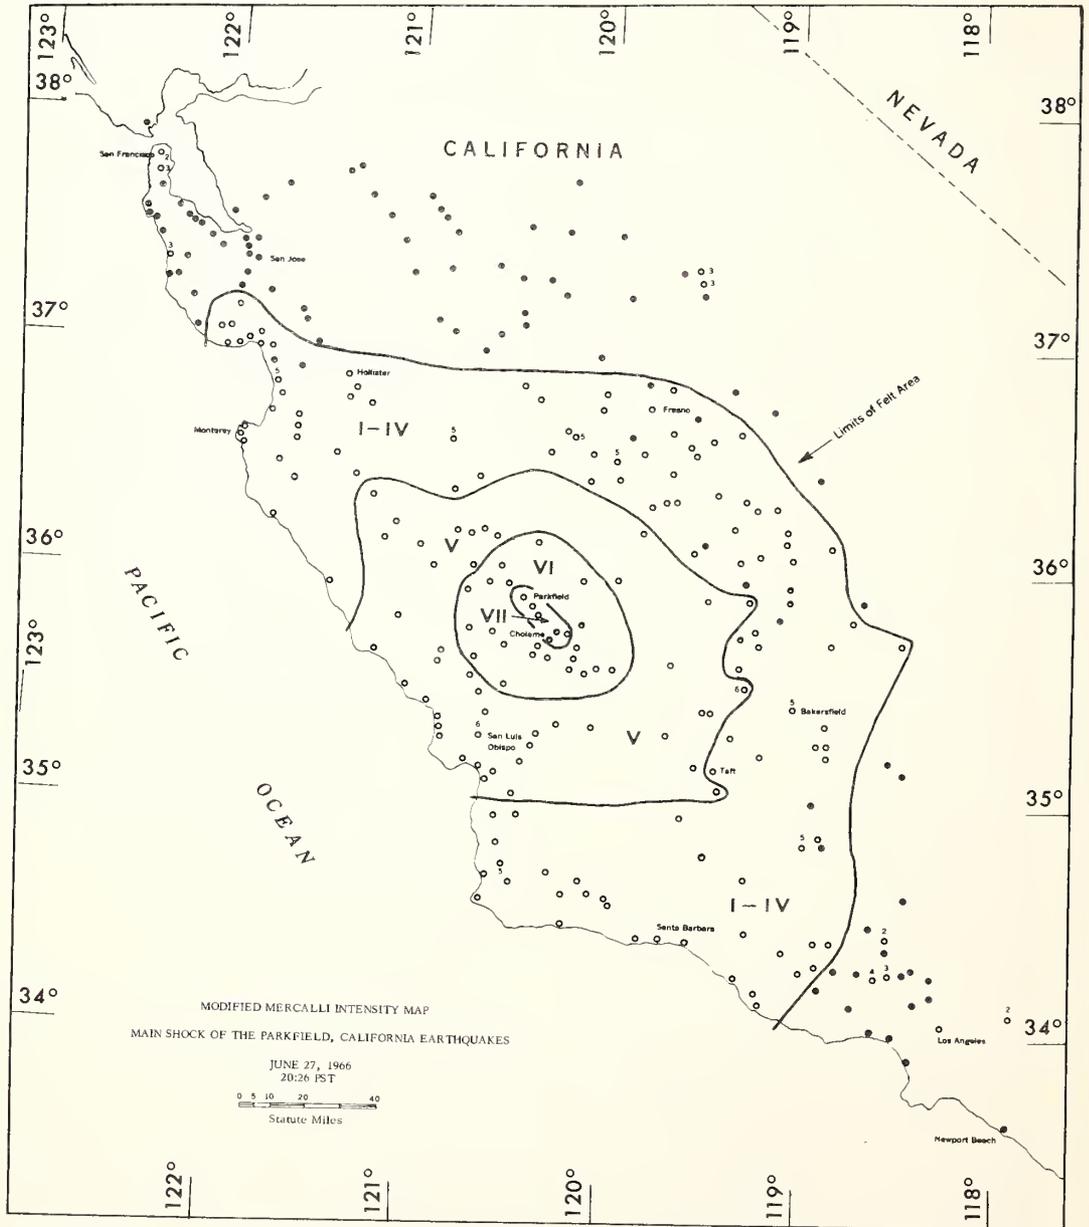
FIGURE 8.—Map showing Modified Mercalli intensity distribution of the June 27, 1966 (20:26:14.4 P.S.T.), Parkfield earthquake.

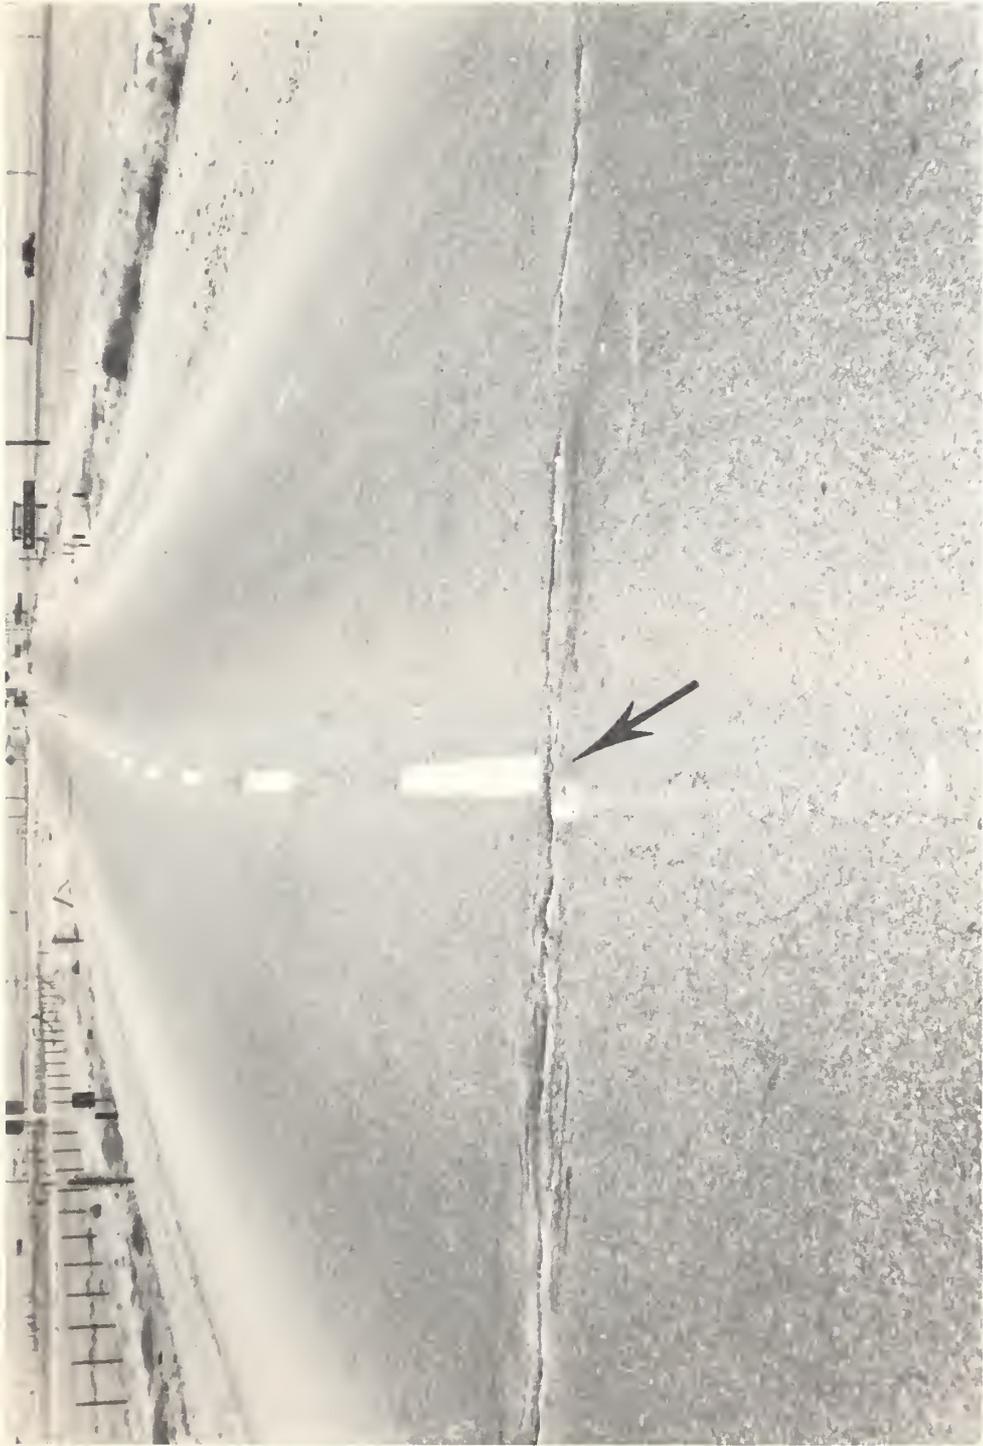
Cholame (about 1 mile northeast of; Strong-motion Station No. 2).—Bridge cracked and pavement buckled (figs. 9 and 15–18). Base-ground separation at power pole (with small

FIGURE 9.—Crack across pavement of Highway 466 about 270 feet east of Strong-motion Station No. 2. Note right lateral movement indicated by arrow. (Photo by George Murray)

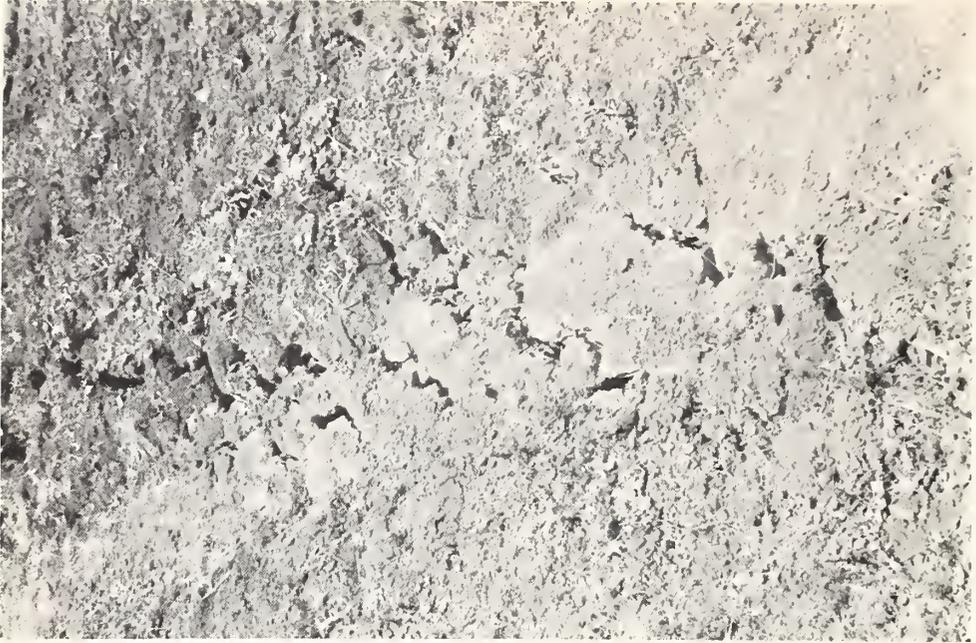
FIGURE 11.—Ground surface fractures about 270 feet east of Strong-motion Station No. 2. View looking southeast. (Photo by Ed Etheredge)

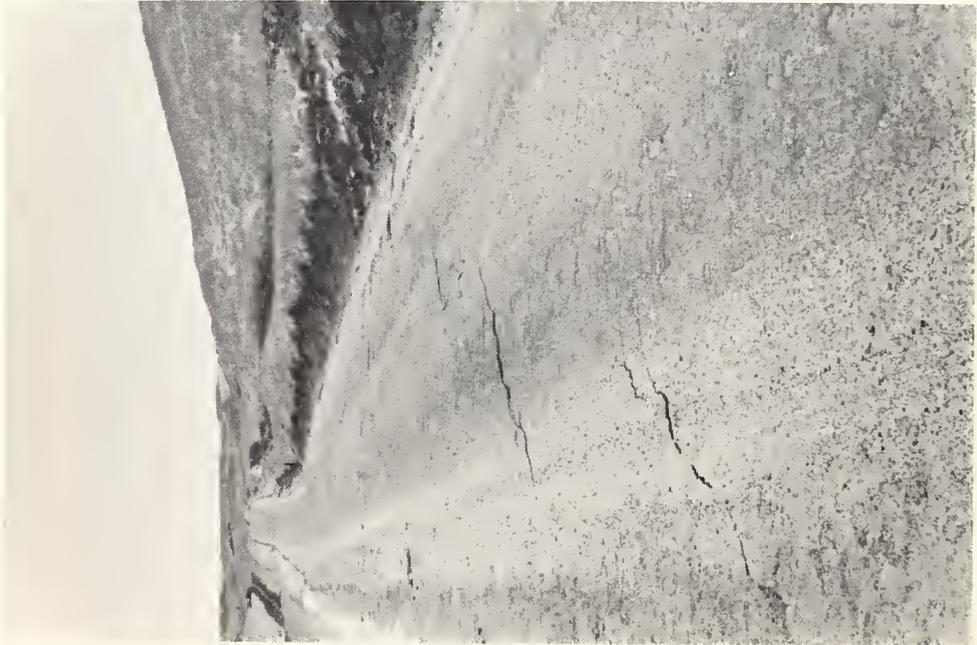
FIGURE 10.—En échelon cracks across road about $\frac{1}{2}$ mile south of Strong-motion Station No. 2. View looking south. (Photo by Ed Etheredge)

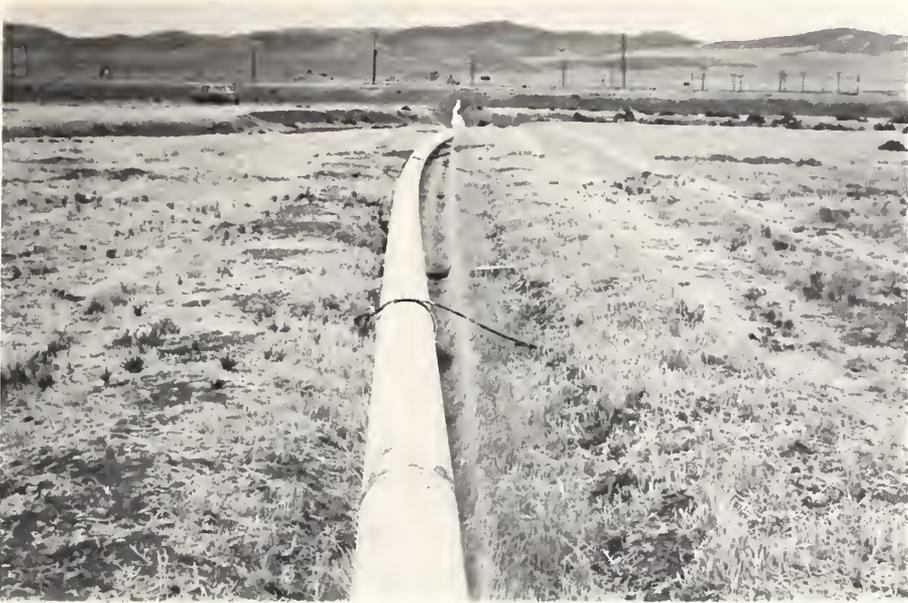
FIGURE 12.—Displacement of pipeline located about 200 yards southeast of Strong-motion Station No. 2. Bent grass indicates original location of pipeline. View looking northeast. (Photo by B. J. Morrill)

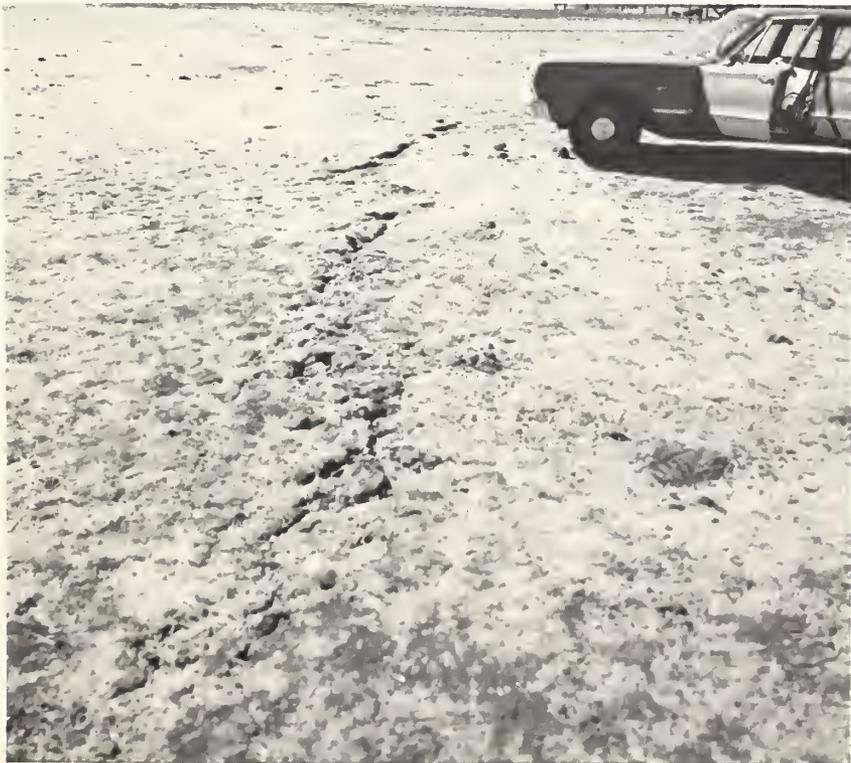
FIGURE 13.—Ground surface fractures about 2 miles northwest of Strong-motion Station No. 2. View looking northwest. (Photo by Ed Etheredge)

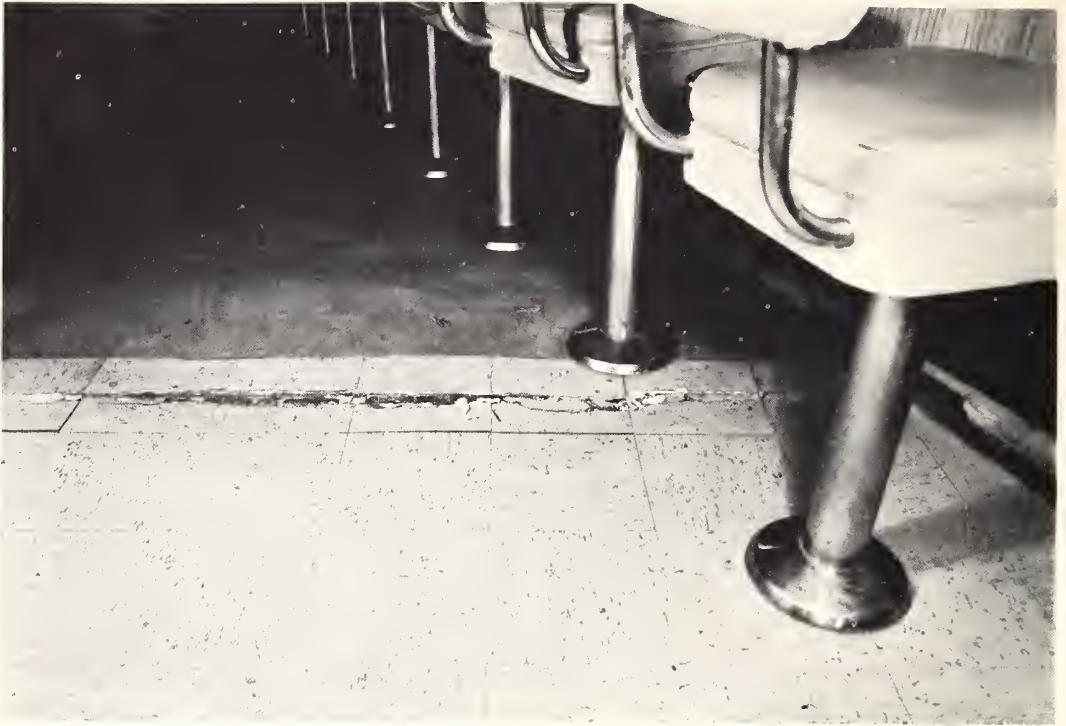
Station, one window cracked near anchoring of shelter ceiling beam, and possible slight buckling of metal fascia. Coke machine shifted southeast. At the Cholame Cafe and Grocery Store, concrete slab floor of front of building separated from older wood floor on wood piers (fig. 14). Many objects fell from shelves.

FIGURE 14.—Crack between concrete slab front of Cholame Cafe and older wood floor on wood pier section of cafe. (Photo by George Murray)

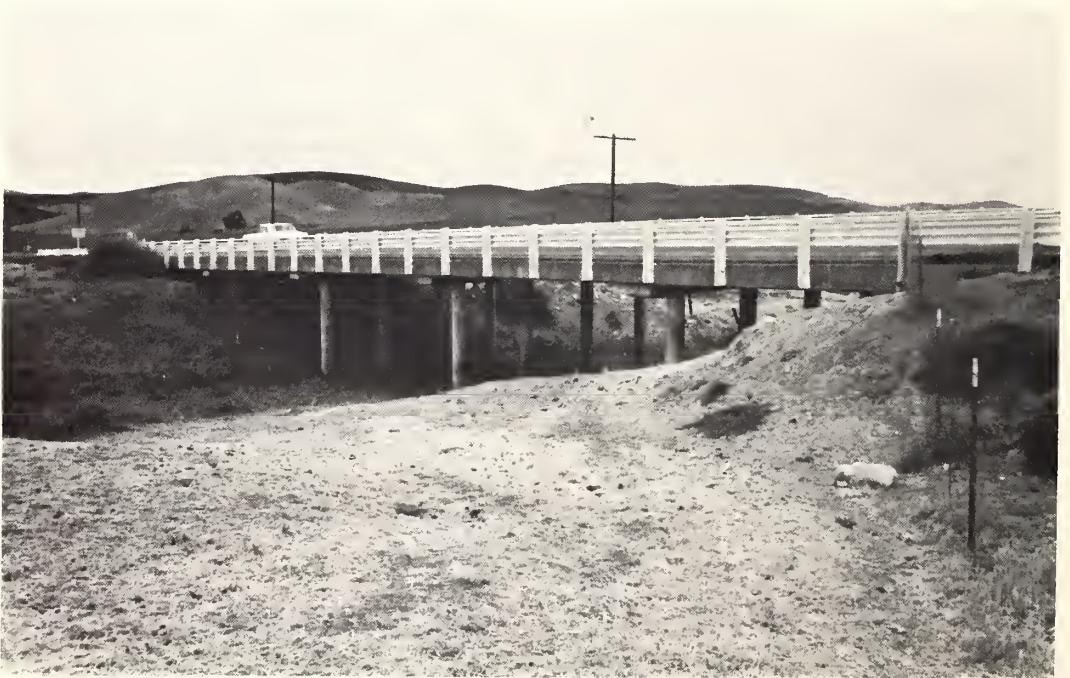
FIGURE 15.—Bridge on Highway 466 about 200 feet west of Strong-motion Station No. 2. (Photo by B. J. Morrill)

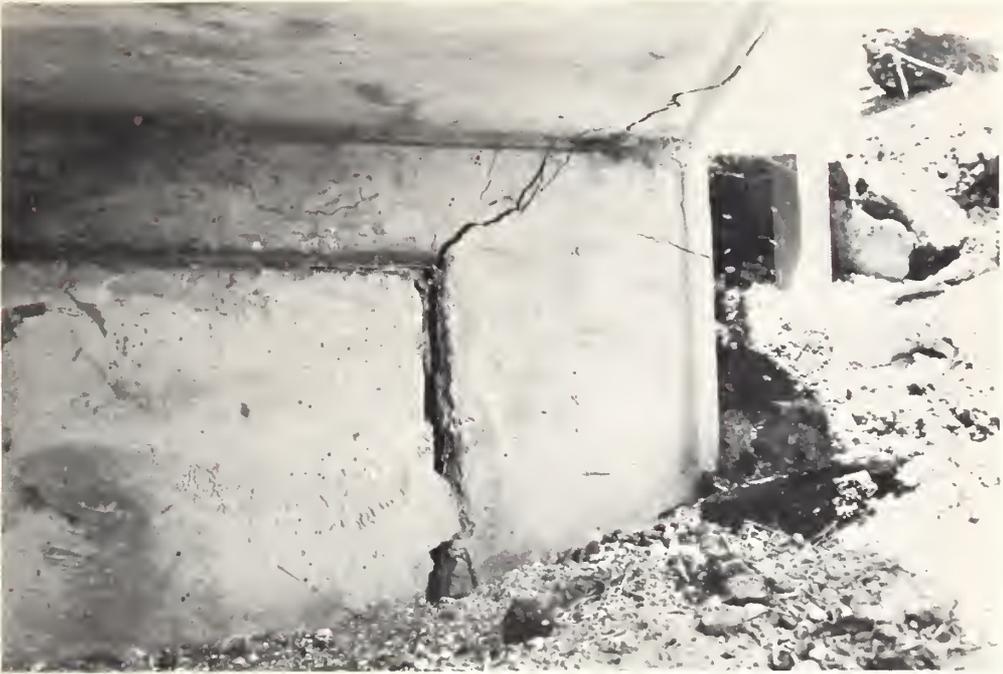
FIGURE 16.—Crack in east abutment of bridge shown in figure 15. (Photo by George Murray)

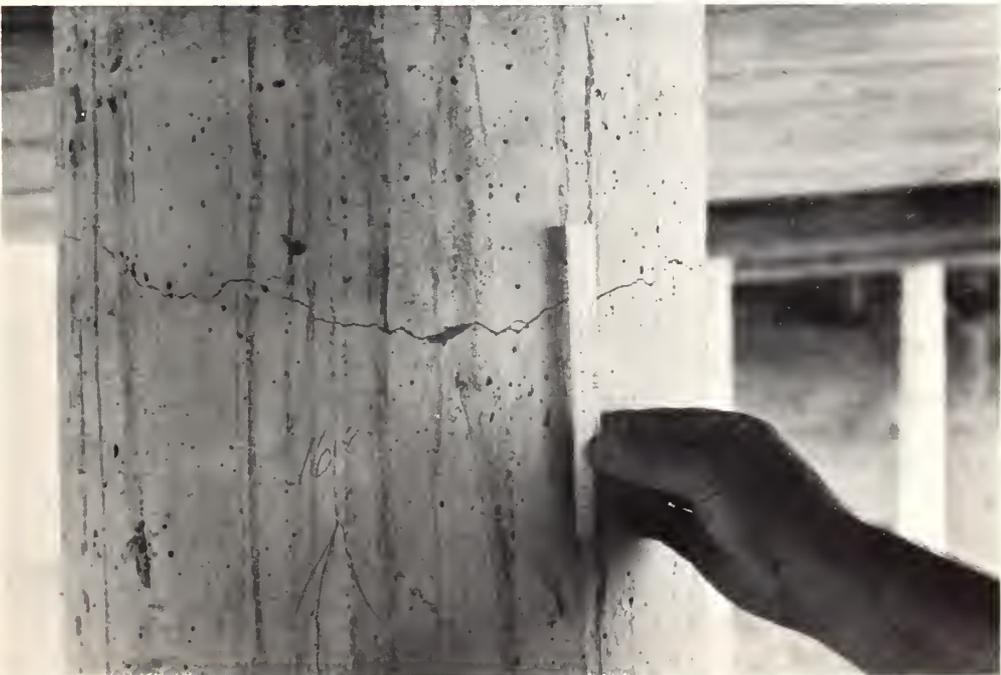
FIGURE 17.—Crack in concrete pier of bridge shown in figure 15. (Photo by B. J. Morrill)

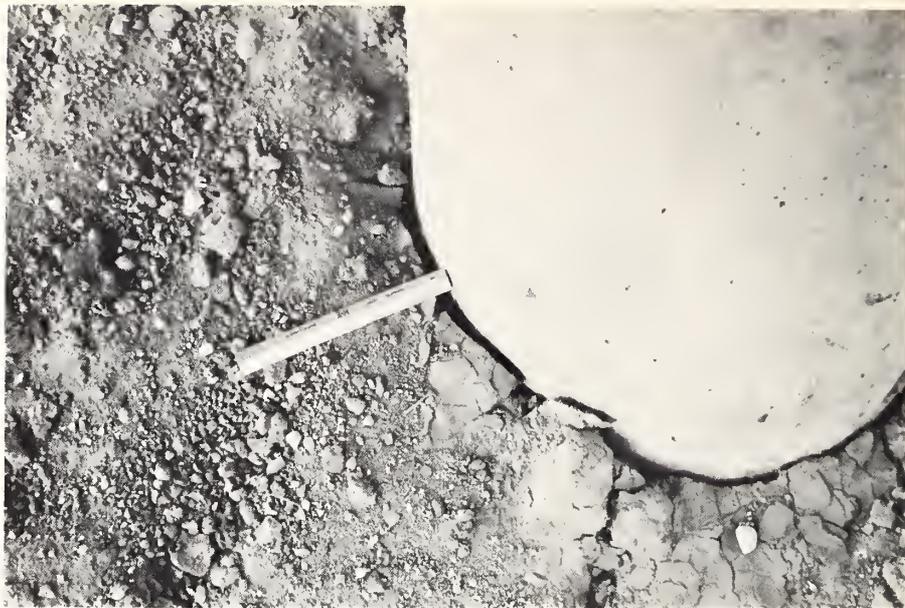
FIGURE 18.—*Indication of motion at bottom of bridge pier shown in figure 17.*
(Photo by B. J. Morrill)

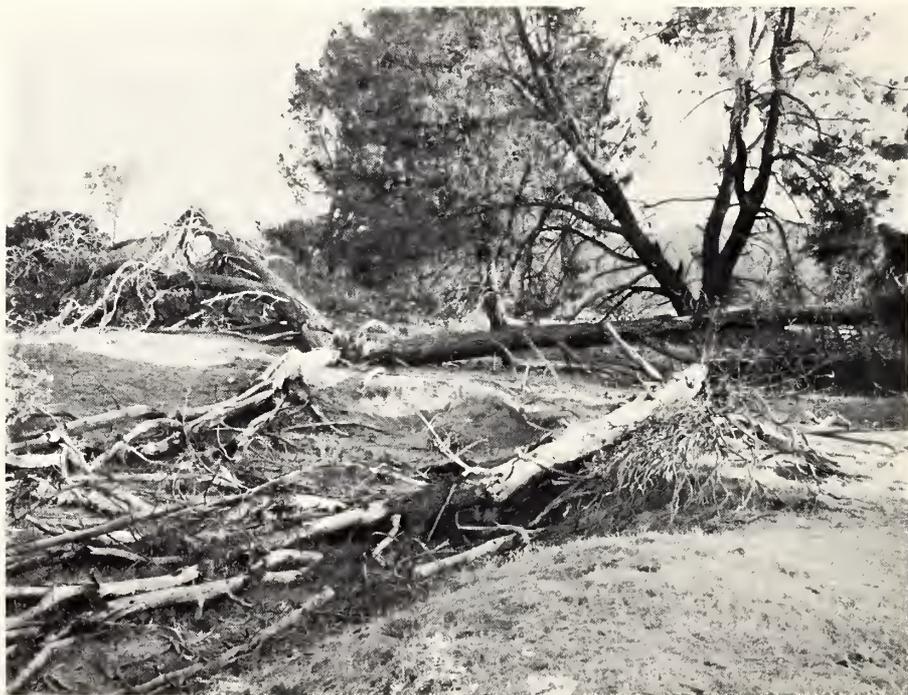
FIGURE 19.—*Dead trees knocked down by earthquake, about 1 mile west of Jack Ranch.* (Photo by Ed Etheredge)

Cholame (north of; Jack Ranch, 6.5 miles north of Highway 466, on the Cholame-Parkfield Road).—Water pipes to stock tank, and irrigation pipe broke. Chimney on bunkhouse broke and slipped $\frac{3}{4}$ inch, but did not fall. About 1 mile west of Jack Ranch, dead trees were knocked over (fig. 19).

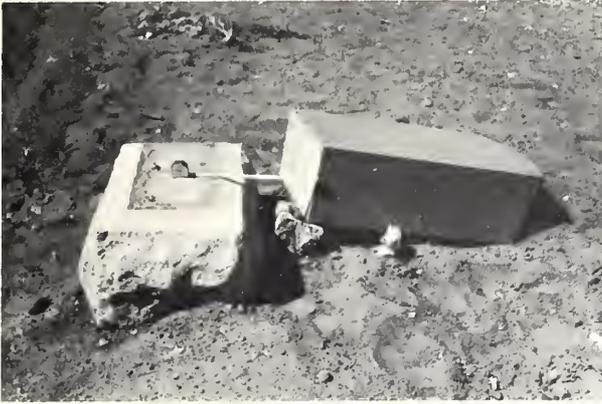
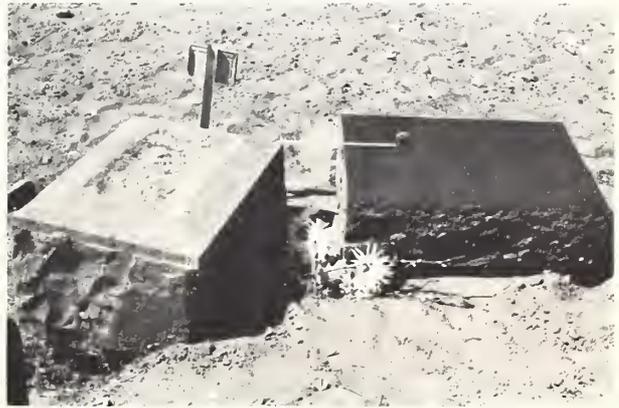
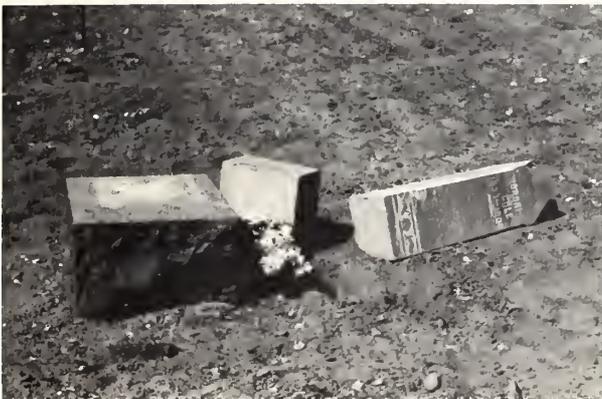
FIGURE 20.—Tombstone at Parkfield, Todd Cemetery. Direction of fall, northwest. (Photo by Frank McClure)

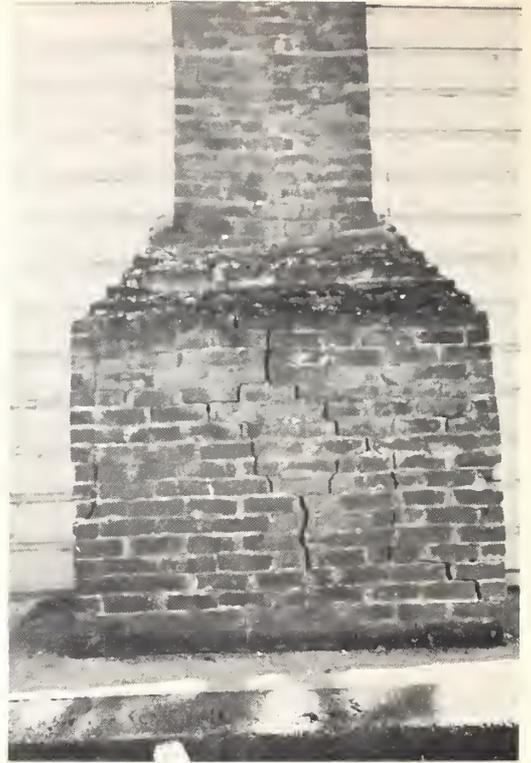
FIGURE 24.—*Close-up of chimney damage shown in figure 23.*

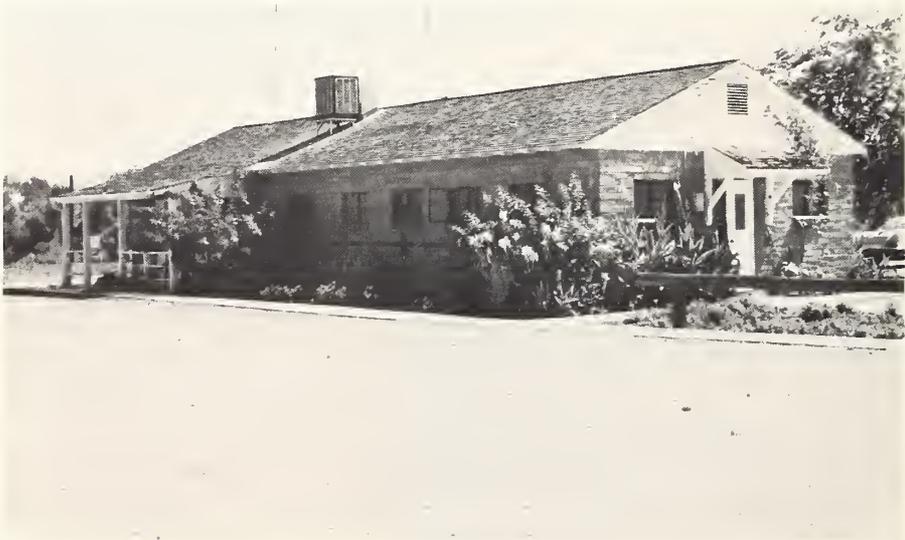
FIGURE 25.—*Parkfield Fire Station. (Photo by George Murray)*

Parkfield and vicinity.—(Press) Water pipes and windows broke at the Parkfield Episcopal Church. Light fixtures broke at the Parkfield School. Floor dropped out of a trailer house. Heavy damage to merchandise at the Parkfield Store. There were numerous reports of minor damage to homes in the rest of the little Cholame Valley, and in Bear Valley which runs just to the west of Parkfield. A 12,000-volt, PG&E power line was torn loose and fell across the phone line serving the forestry station. Fifteen of the 70 telephones in Parkfield were out of service. The forestry service also reported live oak trees were toppled, pulling down wires. The forestry station was slightly damaged by fire touched off by a "hot" wire. It was also reported that several tombstones were overturned in the Parkfield cemeteries (figs. 20-22). At the Parkfield Meeting Hall, a chimney was damaged (figs. 23 and 24), and the west wall was cracked at the fire station (figs. 25 and 26). About five miles south of Parkfield, the X-bracing of a bridge buckled as shown in figures 27-29.

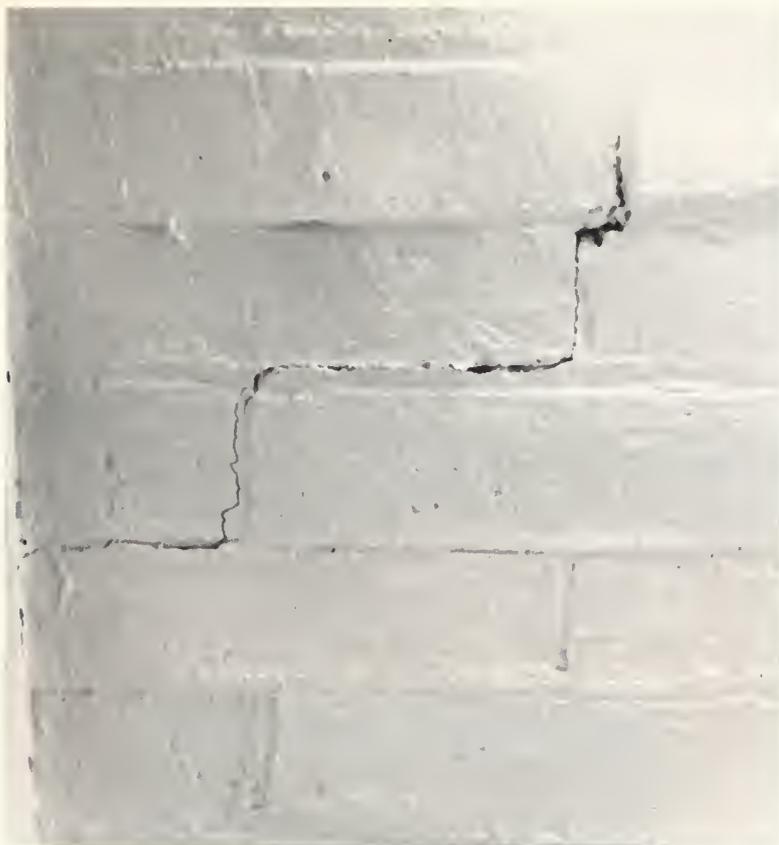
FIGURE 26.—Interior view of cracked west wall of Parkfield Fire Station. (Photo by George Murray)

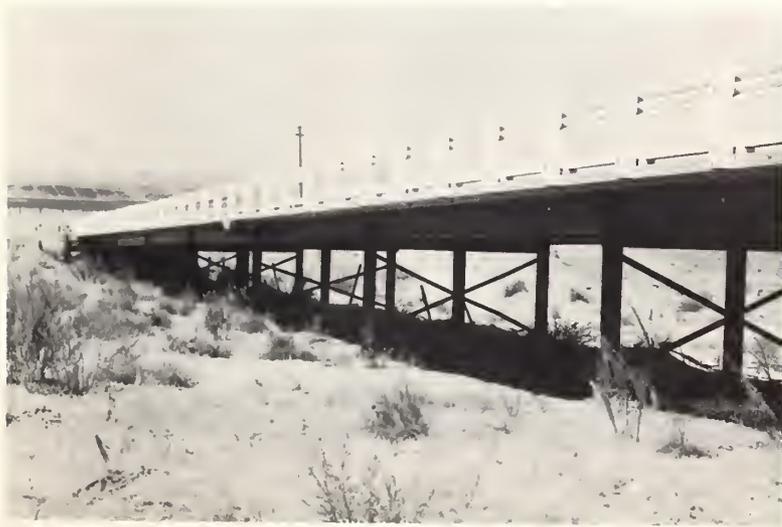
FIGURE 27.—Bridge about 5 miles south of Parkfield. Orientation $N.3^{\circ}E.$ (Photo by Frank McClure)

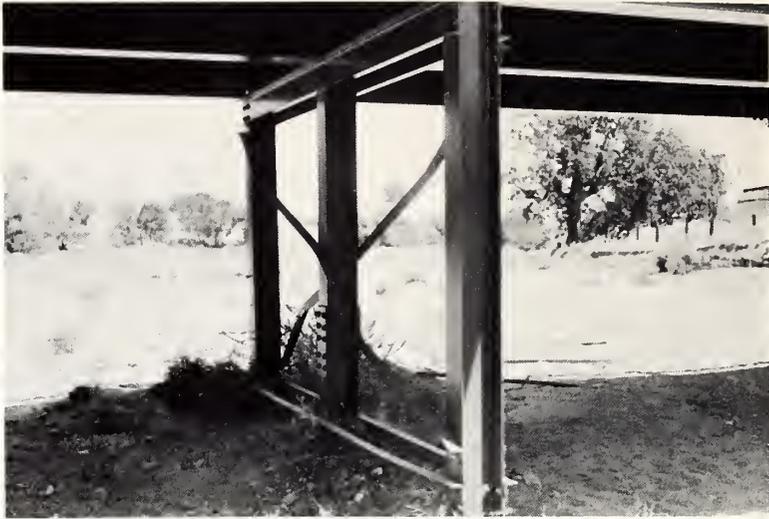
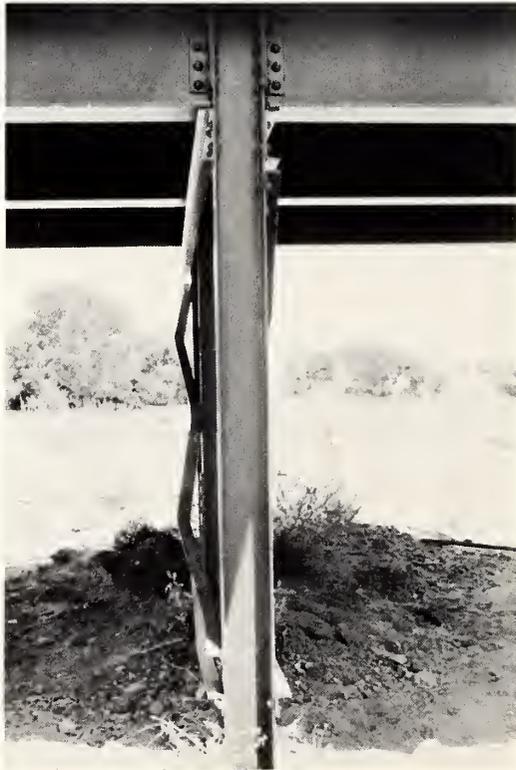
FIGURE 28.—Buckled X-bracing of bridge shown in figure 27. (Photo by Frank McClure)

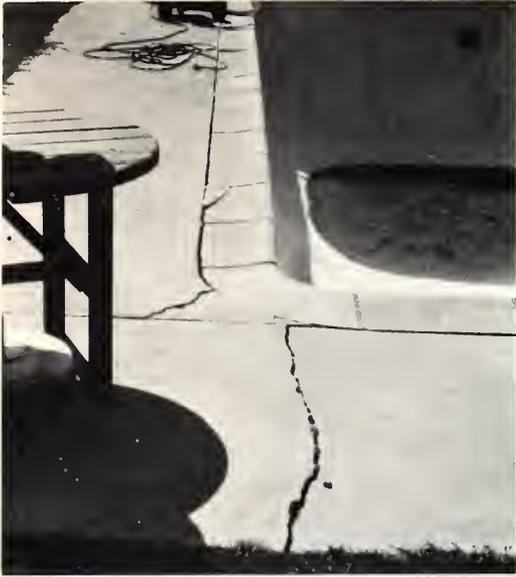
FIGURE 30.—Cracked swimming pool about 2.3 miles south of Parkfield. Adjacent home was undamaged. (Photo by Frank McClure)

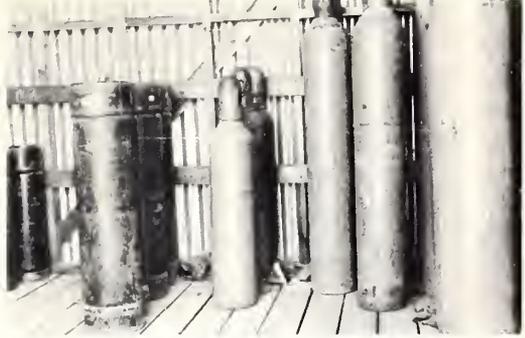
Shandon (northeast of; Strong-motion Station No. 5, Cochrum Garage).—No damage. Several cylinders in the garage fell northeast; tank in the garage shifted northeast. Tall cylinders in an outside shed (raised off the ground on skids and alined approximately parallel to the fault) fell to the southwest (fig. 31). Many tires were thrown southeast out of an overhead rack in the garage. Ground contact to the concrete slab floor of the garage was generally broken. Two soda-water fire extinguishers hanging on wall were set off, but did not fall. Steel-frame building.

FIGURE 31.—Acetylene and oxygen cylinders in Cochrum Garage storage shed reported to have been knocked over by earthquake. (Photo by George Murray)
